# Materials and Electronic Equipment Corrosion Tests in Some U.S. Navy Geothermal Environments

by  
C. Rodgers  
*Public Works Department*  
S. Finnegan  
and  
K. Graham  
*Research Department*

**MARCH 1983**

**NAVAL WEAPONS CENTER  
CHINA LAKE, CALIFORNIA 93555**

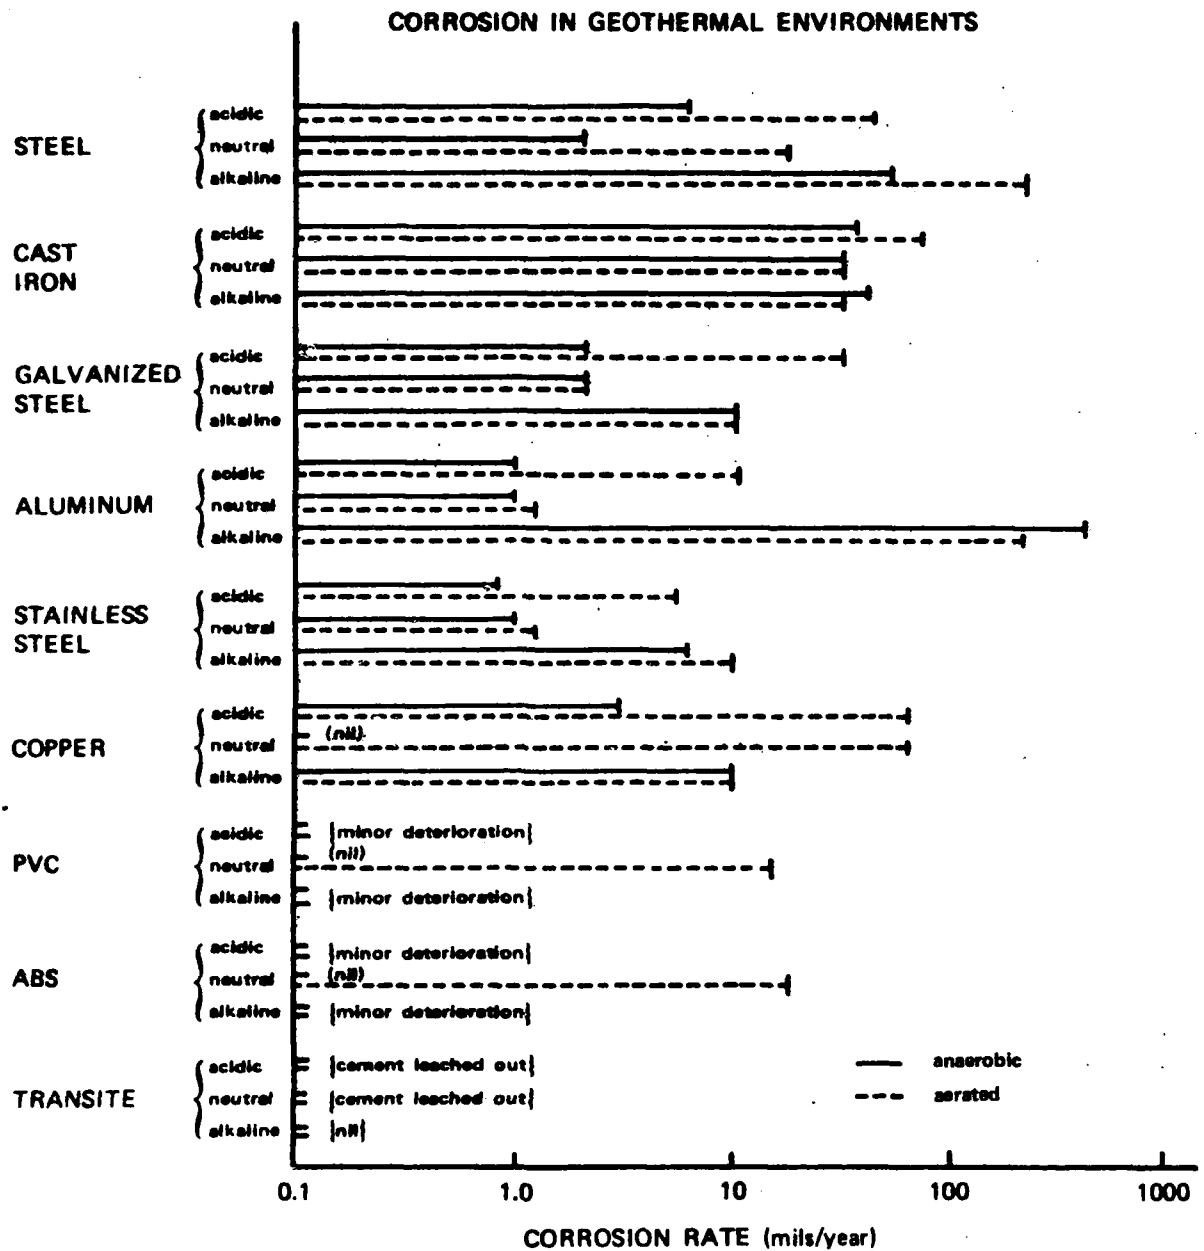
FIGURE 1. A Comparison of Corrosion Rates for Various Materials in Three Geothermal Fluids Found at the Coso Geothermal Area (Ref. 1).

Corrosion studies of common construction-grade piping materials in natural geothermal environments have been previously conducted at the Naval Weapons Center (NWC) (Ref. 1). Ten-foot-long sections of nine different materials were exposed to three different moderate-temperature (less than 220°F) geothermal fluids under both anaerobic and aerated conditions for periods up to about 1 year. Test fluids included two different water-saturated steam environments and a mildly alkaline, saline water. The steam environments included an acid-sulfate site at the Devils Kitchen area and a neutral (pH) groundwater-diluted site at the Coso area. Test materials included mild steel, galvanized steel, 304 stainless steel, gray cast iron, 6063-T6 aluminum, cold-drawn copper, ABS and PVC plastics, and transite. Results from this study are reproduced in Figure 1.

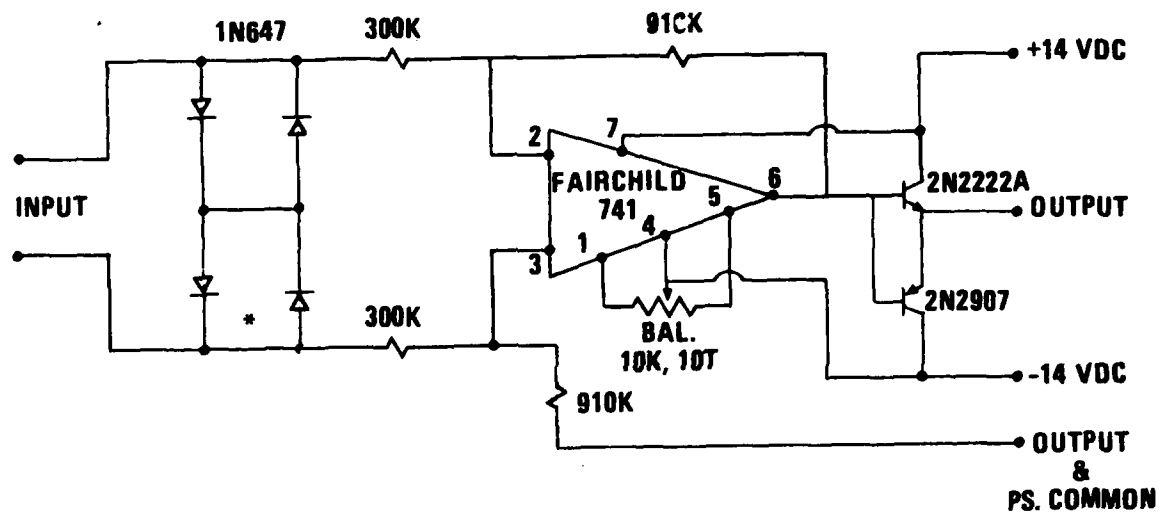
FIGURE 2. Breadboard with Four Integrated Circuit Amplifier Circuit.

\*Circuit #4 - The diode limiters on the input circuit have been removed.

Circuit test data B+  $\pm 15$  VDC, 14 mA

Input voltage	Output
CH. #1 }	0.002	0.375
	0.005	1.247
CH. #2 }	0.002	0.567
	0.005	1.880
CH. #3 }	0.002	0.558
	0.005	1.500
CH. #4 }	0.002	0.428
	0.005	1.33.4

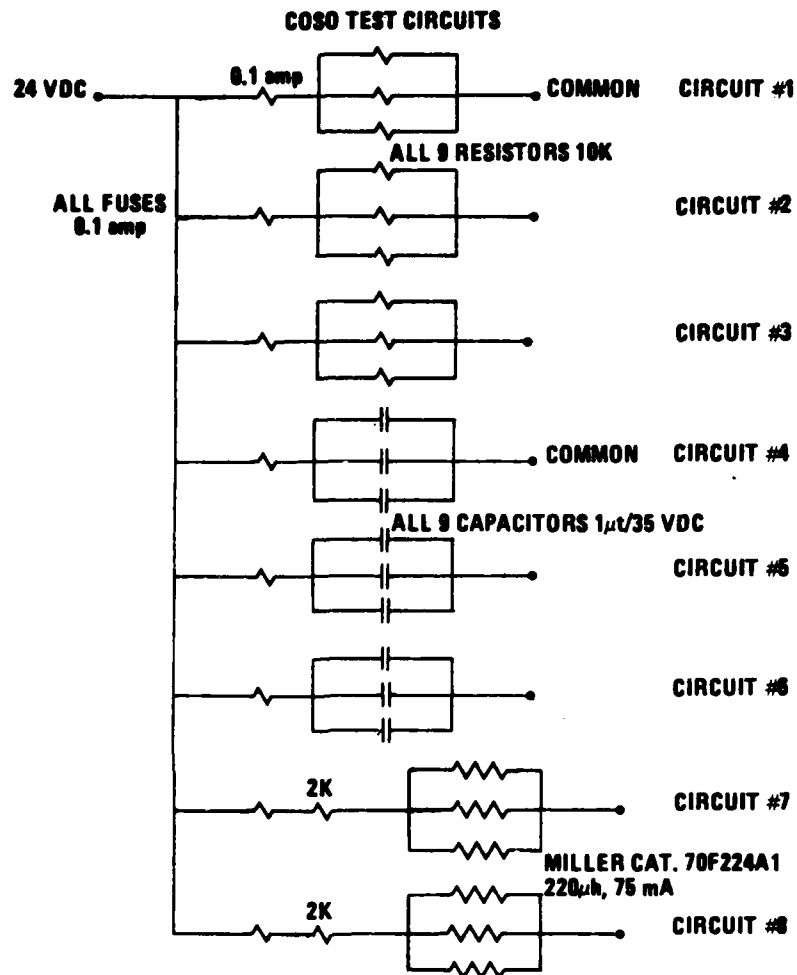
FIGURE 3. 24-VDC Circuit with Resistors, Capacitors, and Coils in Parallel Circuits.

Voltage Source at 24 VDC	
Circuit	Current, mA
1	7.1
2	7.2
3	0.0
4	0.0
5	0.0
6	0.0
7	12.0
8	12.0

Circuits 1, 2, 4, 5, 7 and 8—flux removed.  
Circuits 3, 6 and 9 were not cleaned.
